December 2015 - March 2016

This phase of the project is twofold and involves the installation of secondary bombproof glazing. This removes the requirement for the bomb proof nets previously installed. This new glazing will visually enhance the views both internally and externally of the Banqueting House and provides an improved, more up to date level of protection. The secondary glazing will also deliver an improvement to the thermal and acoustic performance of the building and create a better level of thermostatic control.

The second element of the project is to remove the asbestos debris/dust that currently rests on the back of the Rubens painting. This debris was recently discovered and is the result of an asbestos fire partition that was previously within the roof space and acted as a fire partition. It is believed this partition was poorly removed in the 1970's and it seems that the debris was swept down through the floor boards of the roof space and onto the back of the painting. To enable us to work and carry out conservation to the ceiling in the future, this asbestos now discovered needs to be safely removed.

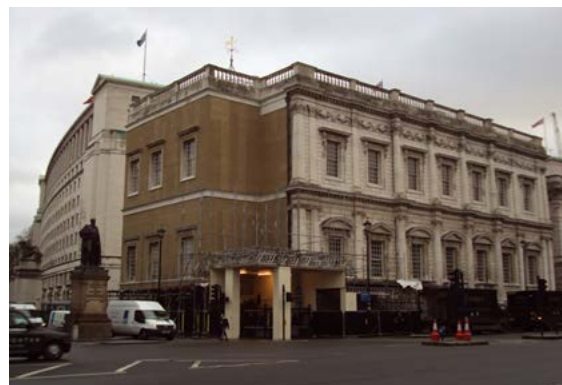
Figure 1: Scaffold struck to below Gantry Level

In December the external scaffold was struck as the conservation work to the exterior of the building nears completion. The cleaning and repairs to the stonework on both the east and west elevations are revealed and include completed repairs, regarding to the weather vane and new leadwork laid around the perimeter of the roof. The new render repairs to the North Annex are also revealed to Whitehall.

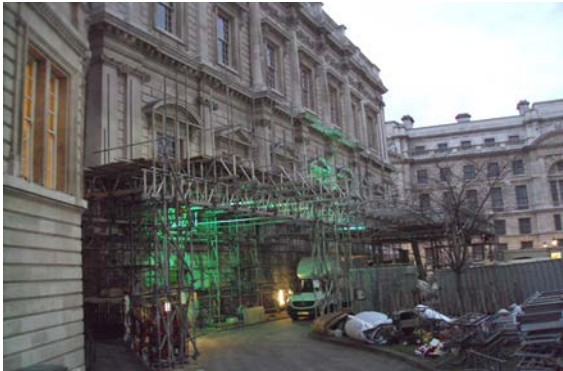
Fig. 2: Scaffold strike at rear of building

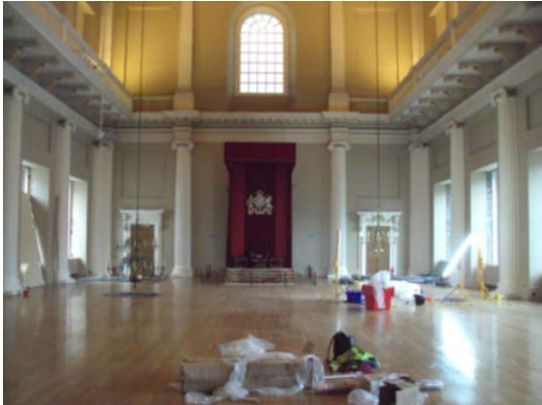
Figure 3: Clearing the hall and removing the window protections

Inside the Banqueting House we prepare for a huge scaffold to go which will reach the windows and provide access underneath the ceiling paintings. The protection is removed from the windows, the chandeliers are lowered and sent away for conservation and display items are moved to storage (Figs 3 - 6)

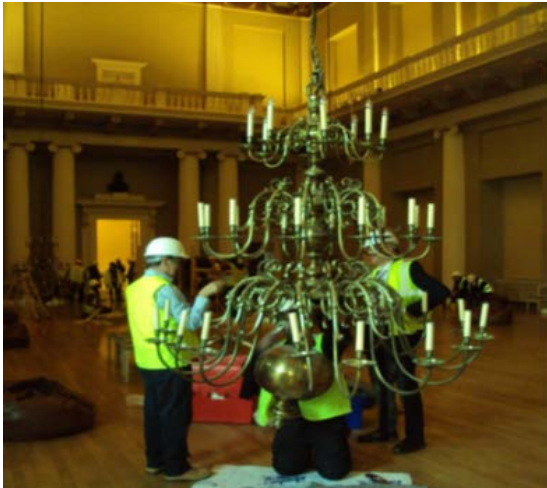
Figure 4: Chandelier specialists at work de-installing

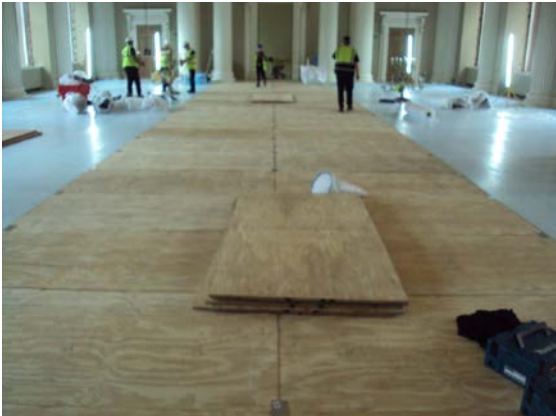
Figure 6: Substantial floor protections are put in place ready for the giant scaffold

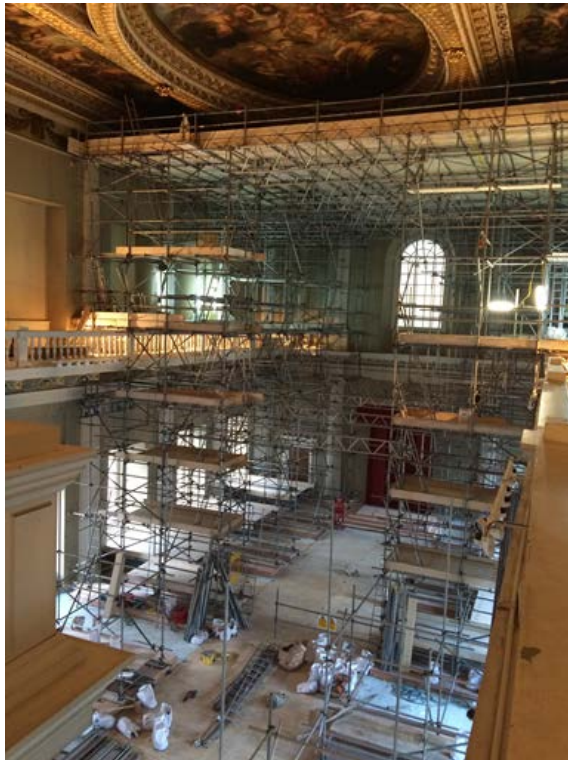
Fig. 8: The scaffold will accommodate work to the windows and ceiling is built in three phases

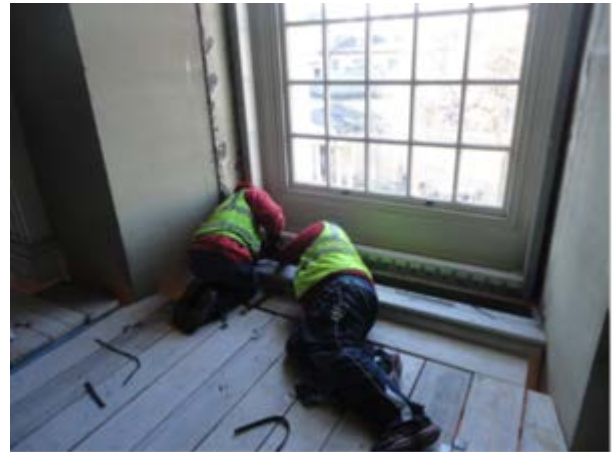
Fig. 9 Final preparation of the new window frames ready to receive the new window

The bombproof nets that previously hung at the windows acted as protection to those within the building to catch the glass in the event of a bomb blast. The majority of the government buildings along Whitehall have these heavy nets and contributed to the perception that Banqueting House was another government building. We have worked closely with our security advisor; a government security advisor and a glazing manufacturer to devise a glazed window that

could offer improved protection and visually enhance the building. Our brief was to design a single unit without glazing bars that would create an unobtrusive view into and out of the Banqueting House but also meet the high level of security that is required.

This design process involved recreating a bomb blast in controlled conditions to ensure that this size of window would take the impact of a blast from the outside. This size of window to this specification is a first!

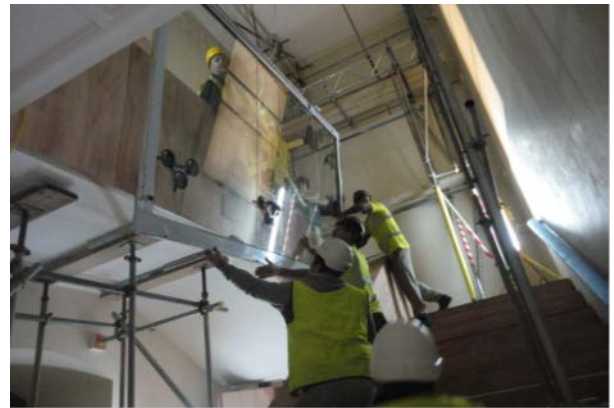
Fig. 10 Lifting the windows on to the first floor

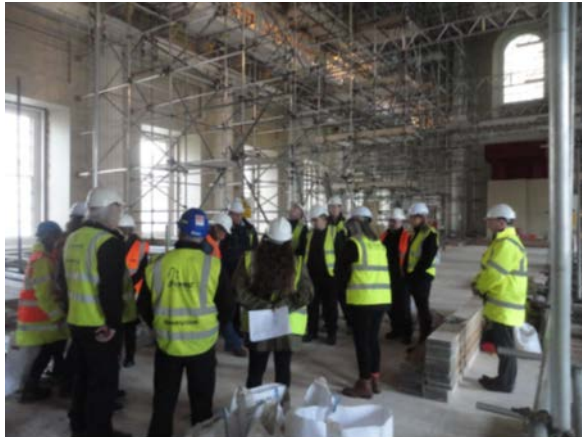
Fig. 11: Conservators and Surveyors briefing the asbestos removal team who will work in close proximity above and below the paintings and coffering

A small amount of asbestos had been discovered on the reverse of the paintings and coffering due to the previous poor removal of a fire partition within the attic. Due to the sensitivity of cleaning in this space the Surveyors and Conservators have worked closely with the selected asbestos removal contractor to devise safe working methods to remove the asbestos fibres with least impact on these delicate structures.

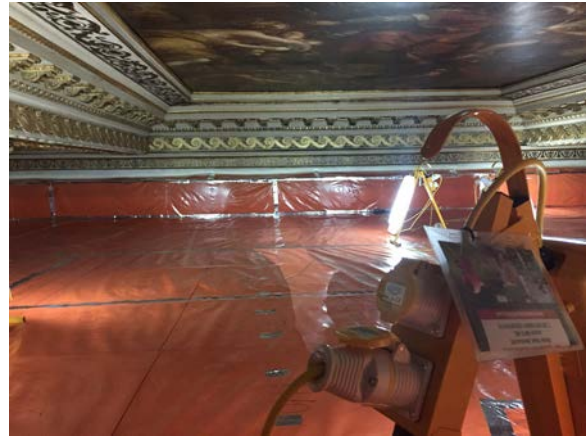
Fig 13: Section 1 is fully enclosed underneath the ceiling
